## History Group notes from the meeting on 20<sup>th</sup> January 2025

### Pennington Point, a perspective from history - John Tindall's Beach Diaries 1922-31

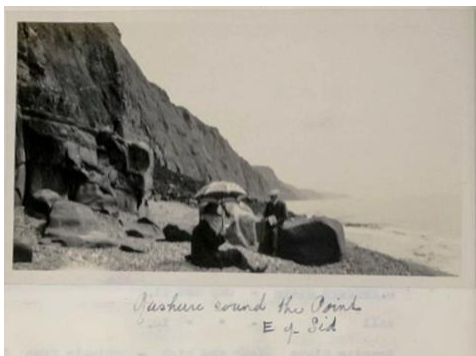
26<sup>th</sup> June 1925, a day after the rushure.

Focusing on Pennington Point and the cliffs east to Salcombe Mouth, Tindall records 116 falls, he uses the old fisherman's term rushures, over the ten years. These varied in scale but 72 of them were significant to substantial. In the last ten years 2015-24 there have been fewer than half that number with 26 falls on East beach significant enough to be mentioned in the Sidmouth Herald.

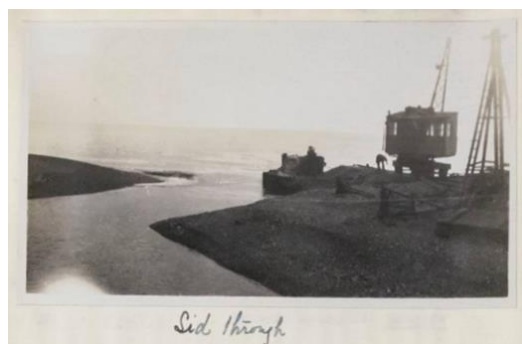
10<sup>th</sup> January 1926, working at Port Royal

In an effort to stabilise the shingle at Port Royal where the boats were hauled up, the guiding wall alongside the river was extended and the rocks from the disintegrating Dunning's Pier were piled alongside the river. Tindall raised a concern about the impact.

The effect on the shingle was marked. During the early 1920s, Pennington Point was protected from wave action by a huge bank of shingle. This would wax and wane according to storms, but it was usually substantial enough to not only protect the cliff but to close the river. From 1922-4 the river was closed by shingle on average 223 days of the year. After the work on Port Royal, from 1929-31 it was only closed for 63 days each year on average.

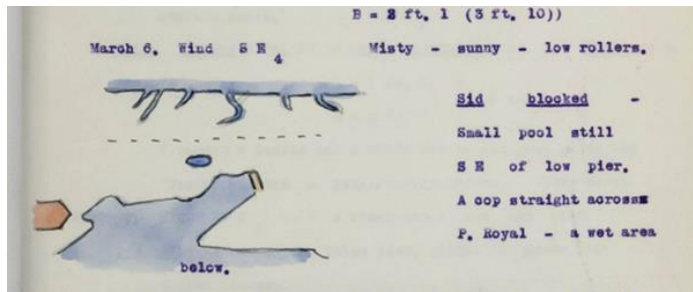
March 6<sup>th</sup> 1924, Tindall sketch of river seeping through shingle bar, the left hand red block is Pennington Point.

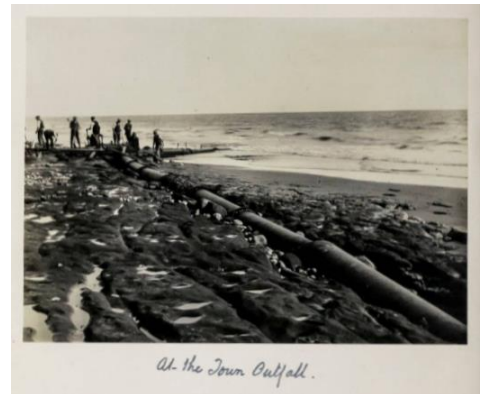
December 1927 town drain exposed

In the 1890s, a new sewer outfall was constructed from a storage tank under The Ham, across the river and discharging well along East beach. The shingle was sufficient to need a permanent 'manhole' in the river to allow access to the pipe below. After the extension of Port Royal the 'manhole' often stood proud of the river bed and, in 1927, the sewer outfall was exposed and needed urgent repair. Incidentally, the sewer outfall was operated manually with a sluice gate on the storage tank opened when the tide was running eastwards.

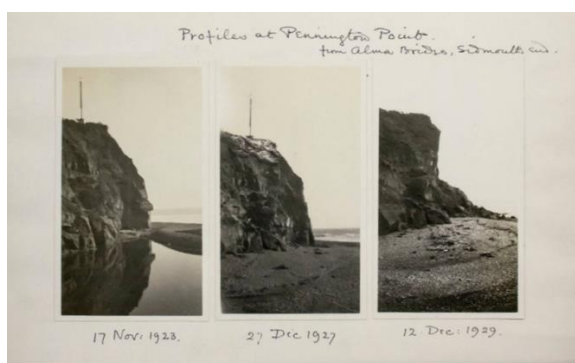
The large rock at the cliff foot is a useful reference point.

In 2015 much was made of a picture of cumulative erosion. Again, there is nothing new, Tindall was able to show just as striking a change in 1929.

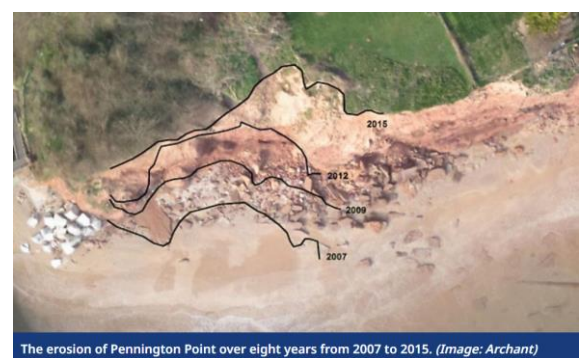
Cumulative montage, Sidmouth Herald 15<sup>th</sup> May 2015
